# Manhole Inspection Summary

Manhole # S33C\_\_020MH

Insp Date: **12/9/08 2:11 PM**

**Location** Address: **unknown alley**

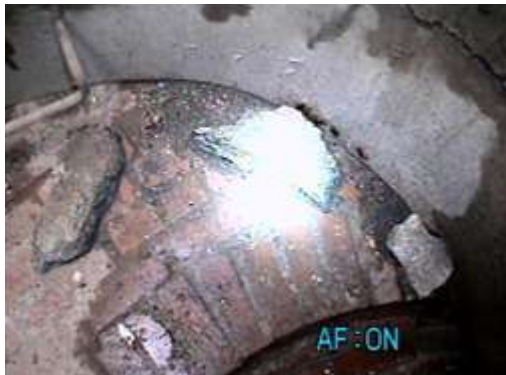
Miscellaneous

bench debris

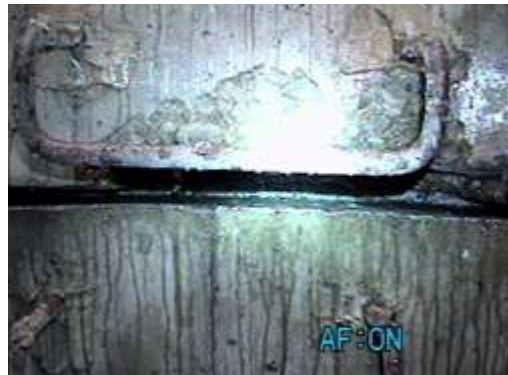
Defect 3

Condition: ☐ Sound ☒ **Cracked** ☐ Root Intrusion ☐ Loose Brick ☐ Deteriorated

corbel cracked

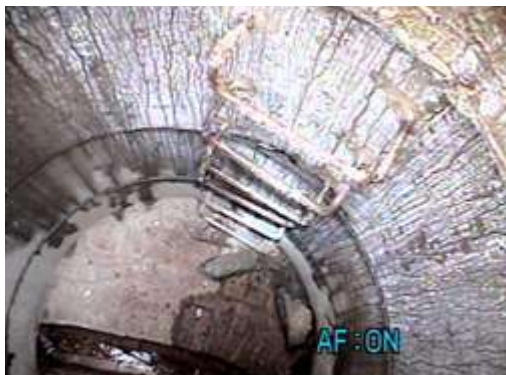
Defect 1

Infiltration: ☐ None ☒ **Joint** ☐ Cracks ☐ Mortar ☐ Roots ☐ Wall

**Steps** Count: **6** Missing: **0** ☒ **Corroded**

steps corroded, infiltration from chimney through corbel and barrel

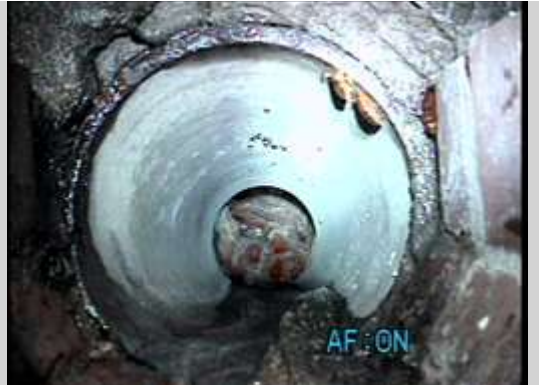
12 O'Clock Outflow

8 in. Circular Gravity Sewer  
Pipe Out @ 12 O'Clock

Pipe Material: **Clay** ☐ Pipe Lined

Invert Depth: **8.88** (ft.) Flow Characteristics: **Slow**

Infiltration: **None** Pipe Seal Cond: **Unknown**

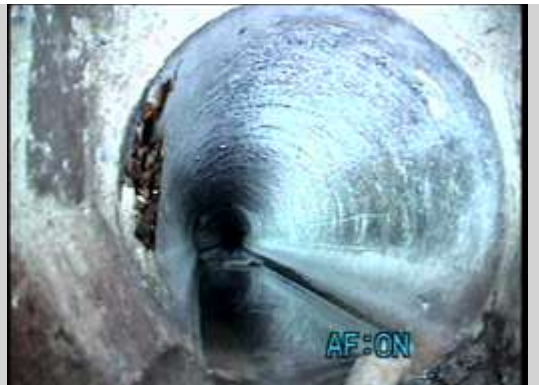
4 O'Clock Inflow

8 in. Circular Gravity Sewer  
Pipe In @ 4 O'Clock

Pipe Material: **Clay** ☐ Pipe Lined

Invert Depth: **8.43** (ft.) Flow Characteristics: **Slow**

Infiltration: **None** Pipe Seal Cond: **Unknown**
